ELECTRIC POWER
RESEARCH INSTITUTE

NDE of Reactor Materials

ATR National Scientific User Facility
Users Week, June 1-5 2009
Idaho National Laboratory

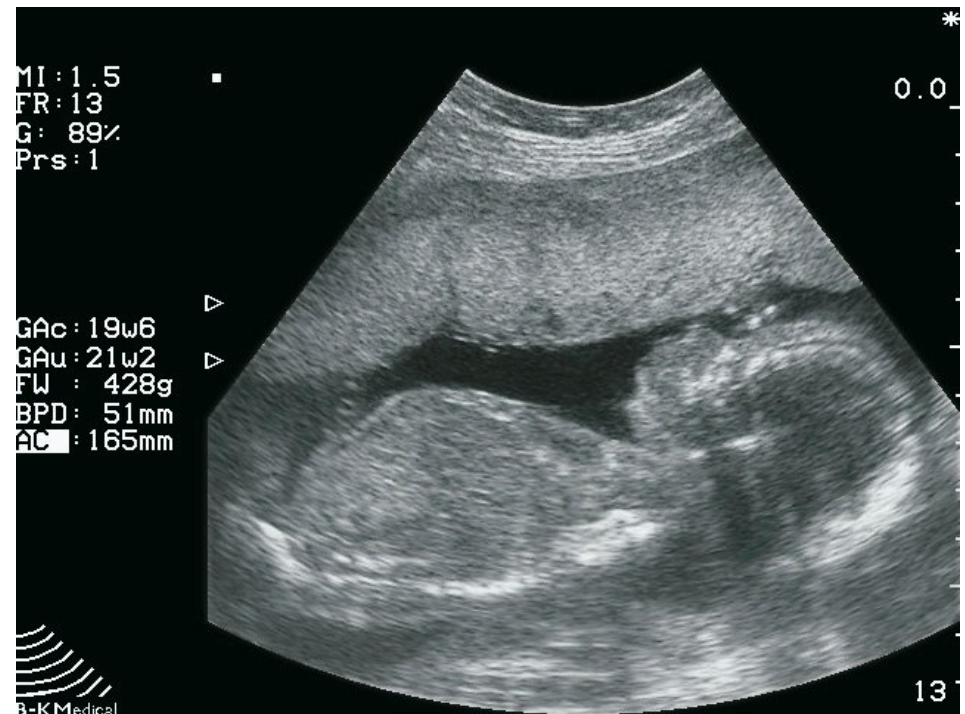
Phased Array UT

- Imaging technique similar to medical ultrasound
- Increasing in importance lately in nuclear NDE
 - Equipment is getting smaller, cheaper, and more powerful
 - Demands for speed are increasing
 - Cost
 - Low dose

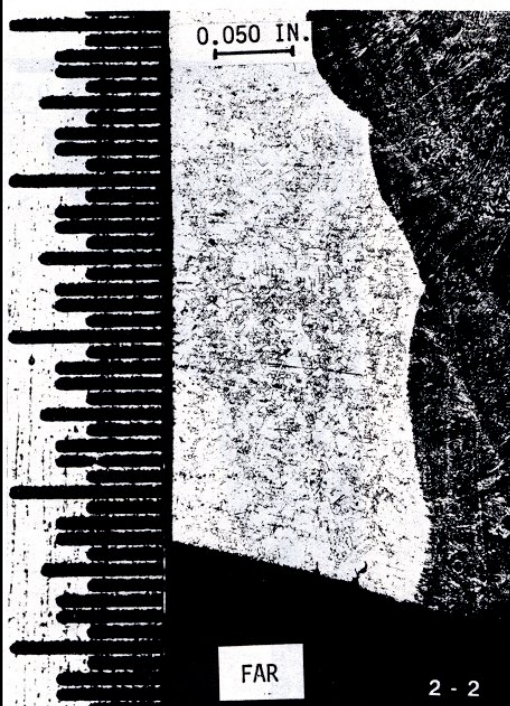
BWR Recirculation Piping-IGSCC

Typical IGSCC found in stainless steel BWR recirculation system piping

- Located in Heat Affected Zone of base metal
- Branched

Example of deep cracking

- Grows toward weld
- Usually follows weld profile after reaching the weld

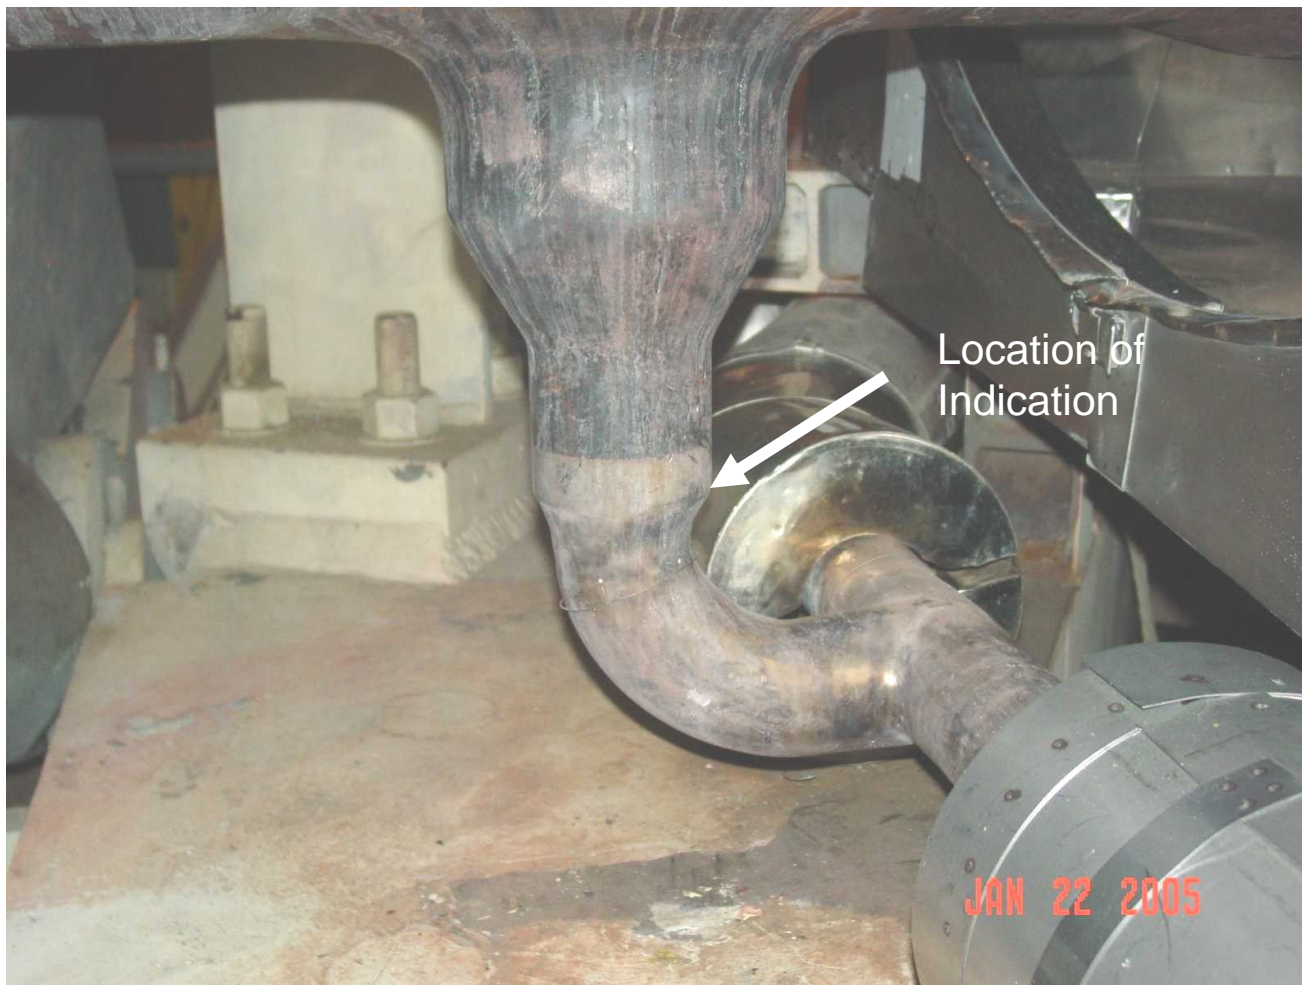
RCP 1-1 Cold Leg Drain

- Indication detected in a PWR cold leg drain line dissimilar metal weld
- Evaluated as a defect
- Overlay repair designed and installed

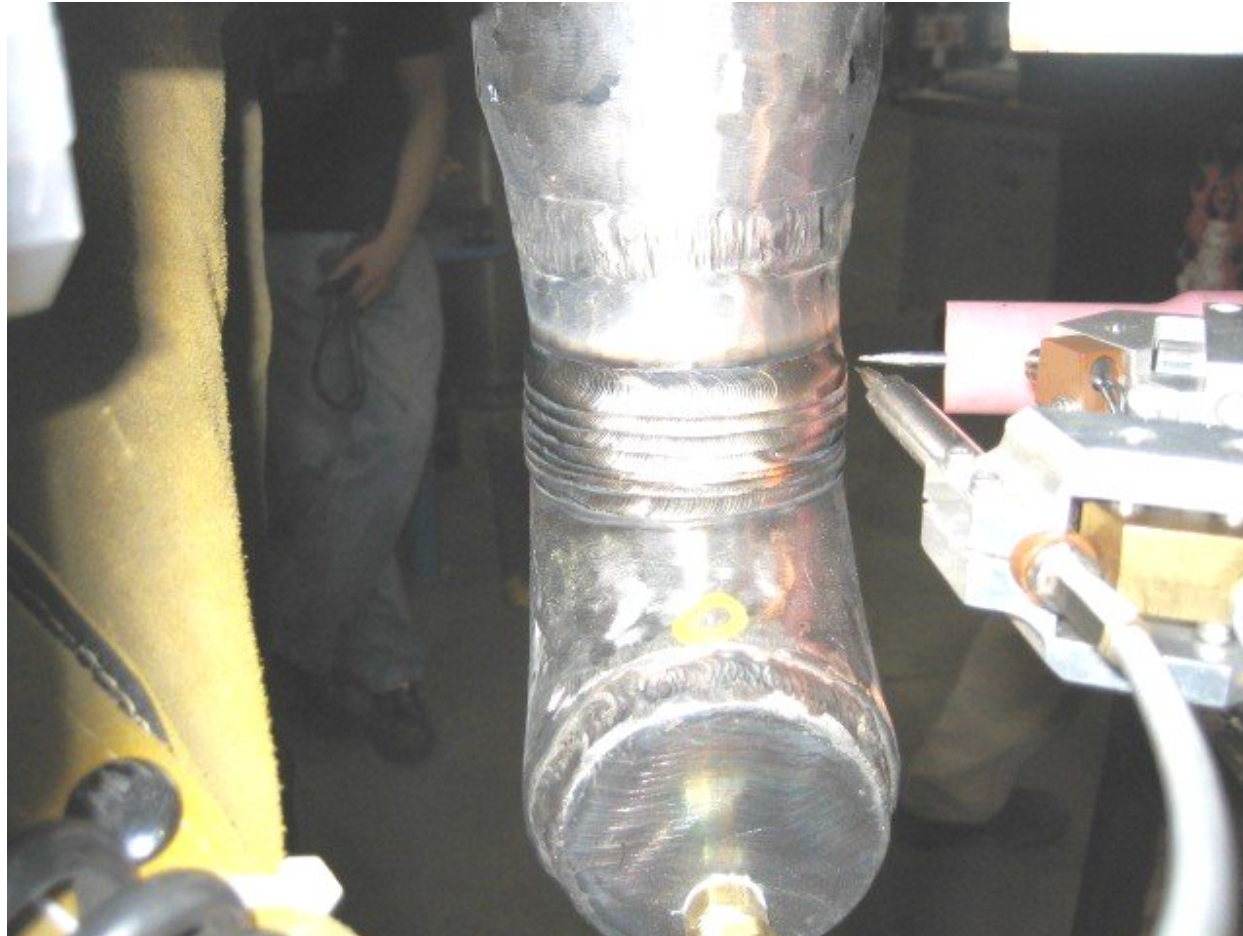
Mockup for Welding Proof of Principle
WSI Norcross, GA

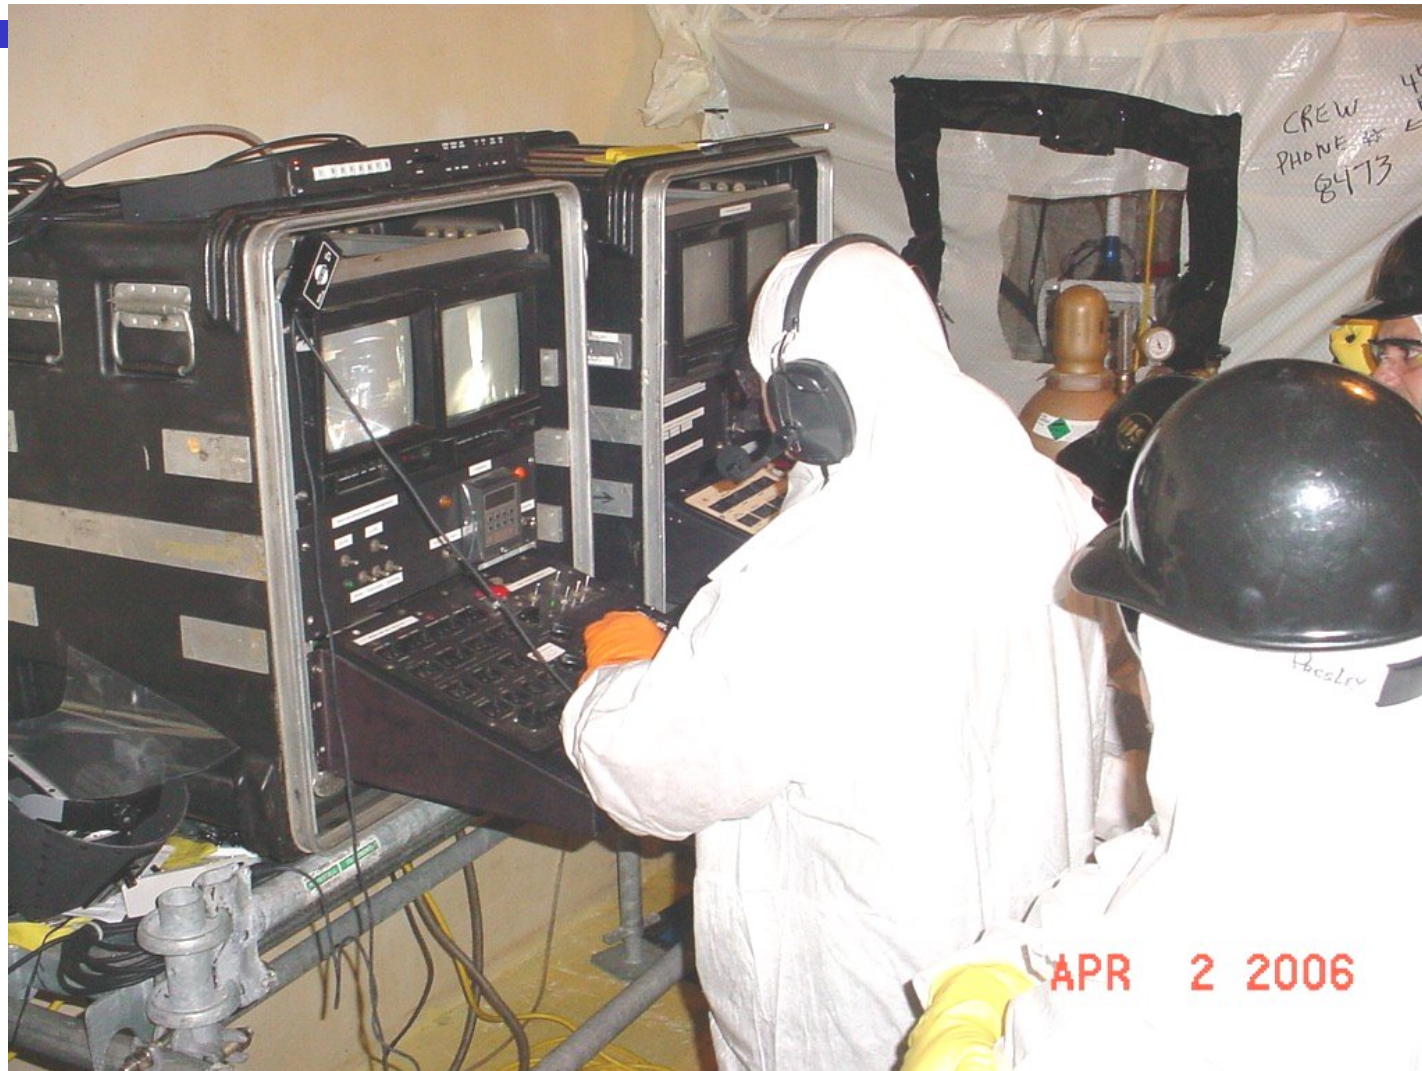
WSI Remote Welding Operation

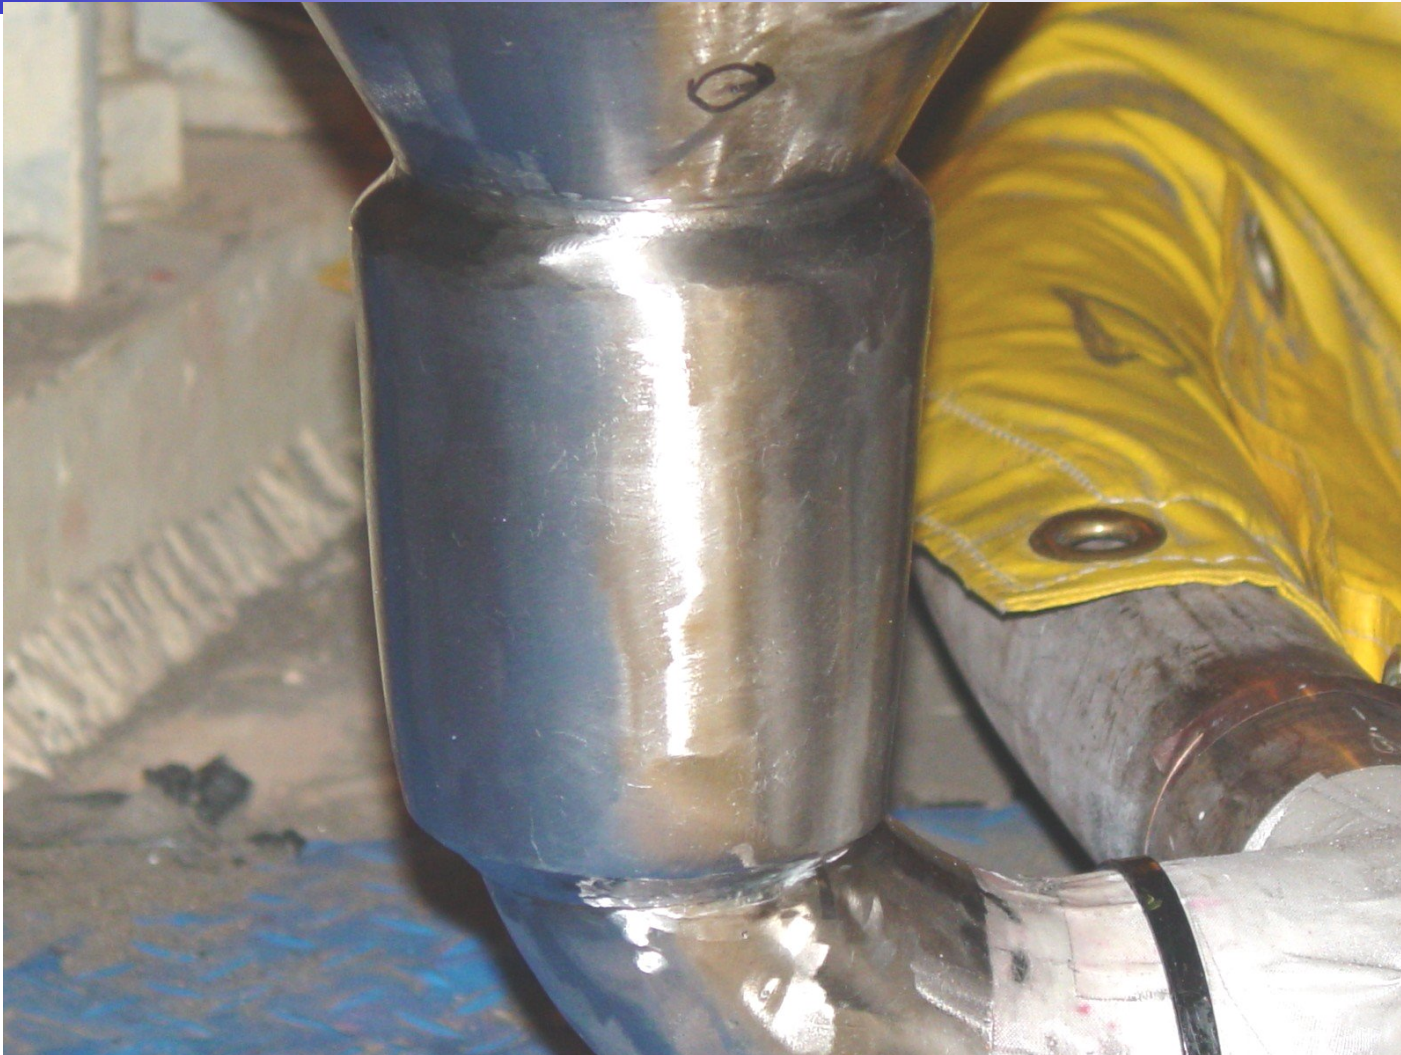
Final UT'd Overlay – 16 Days 6 Hours After Indication Discovery

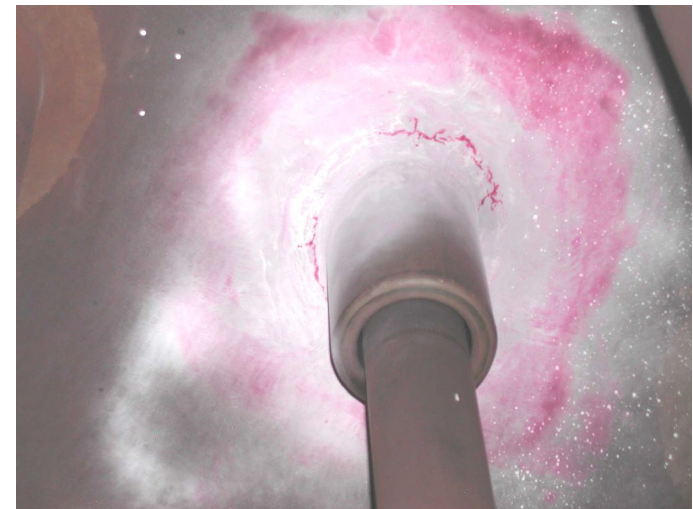
Base metal
PWSSC

J-Groove weld
cracking

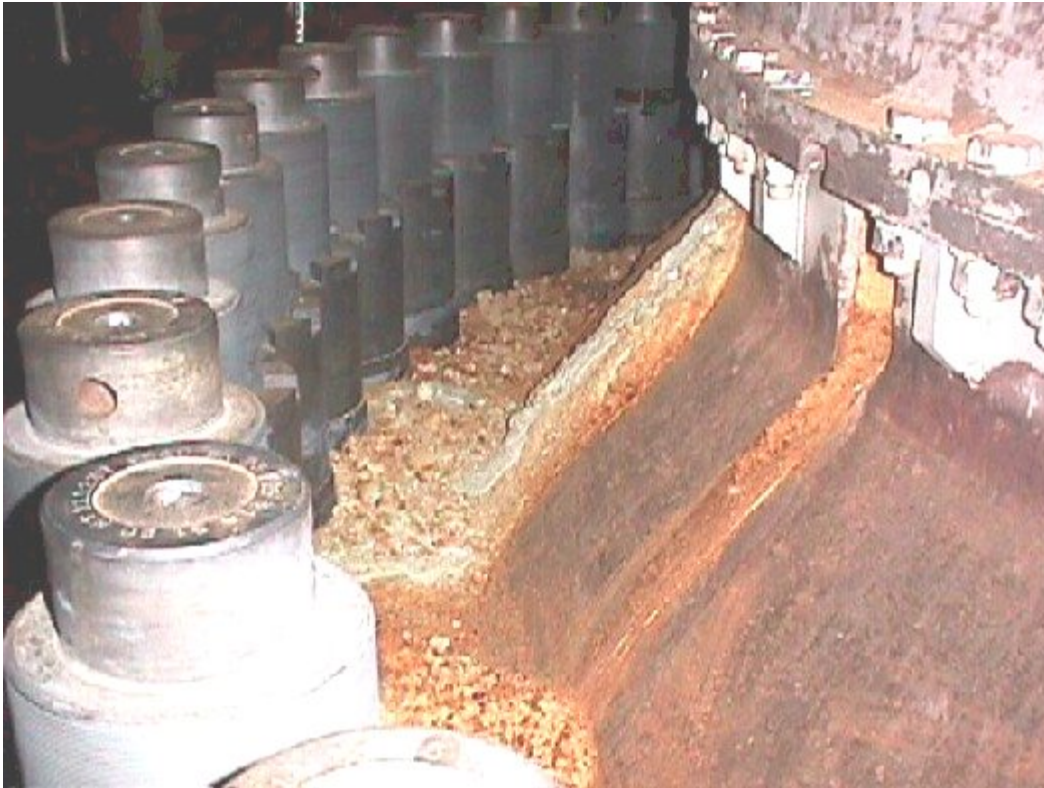
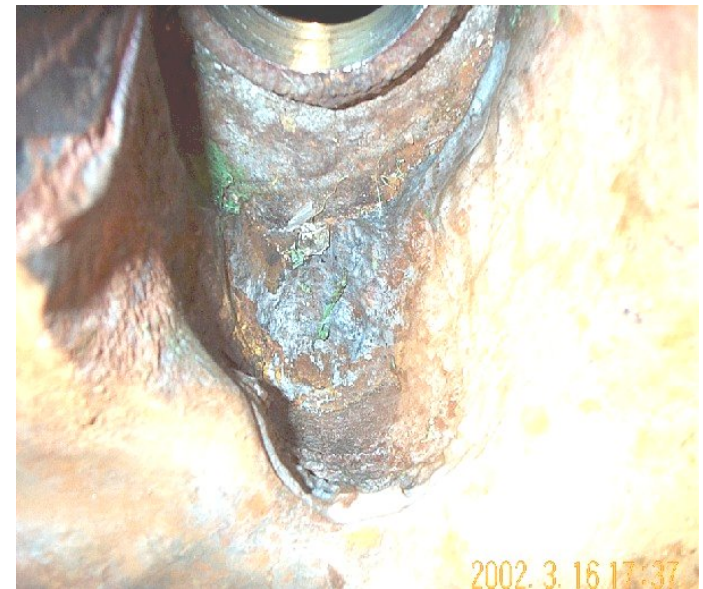
Evidence of Leakage

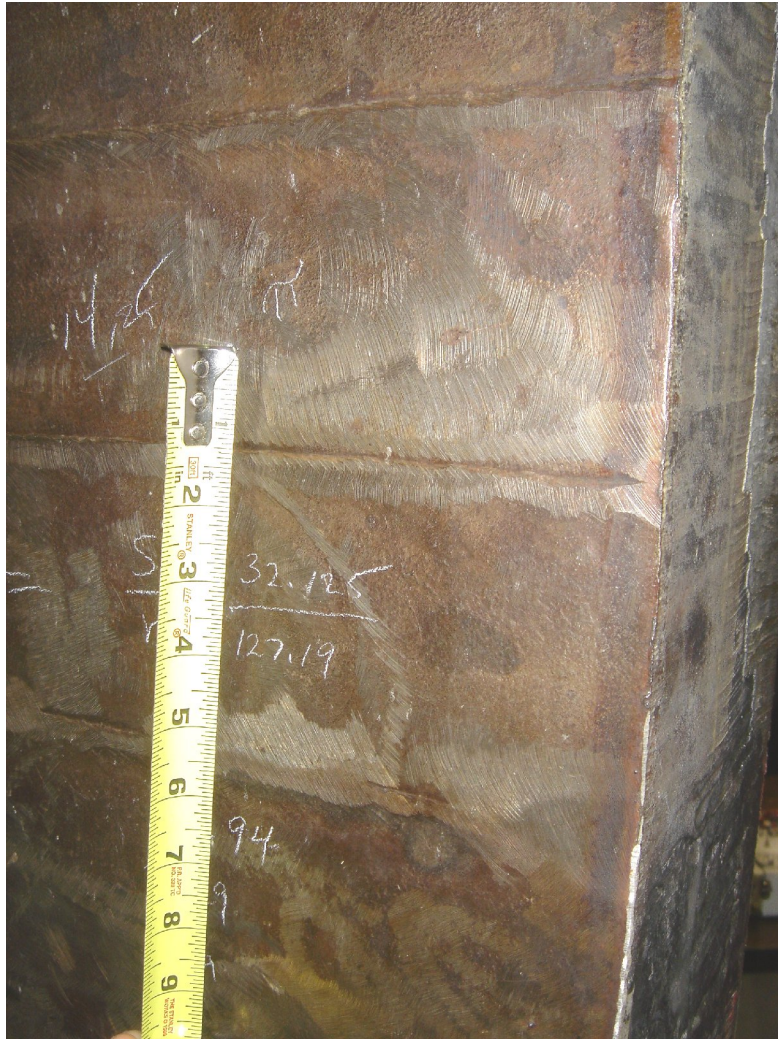
Automated welding

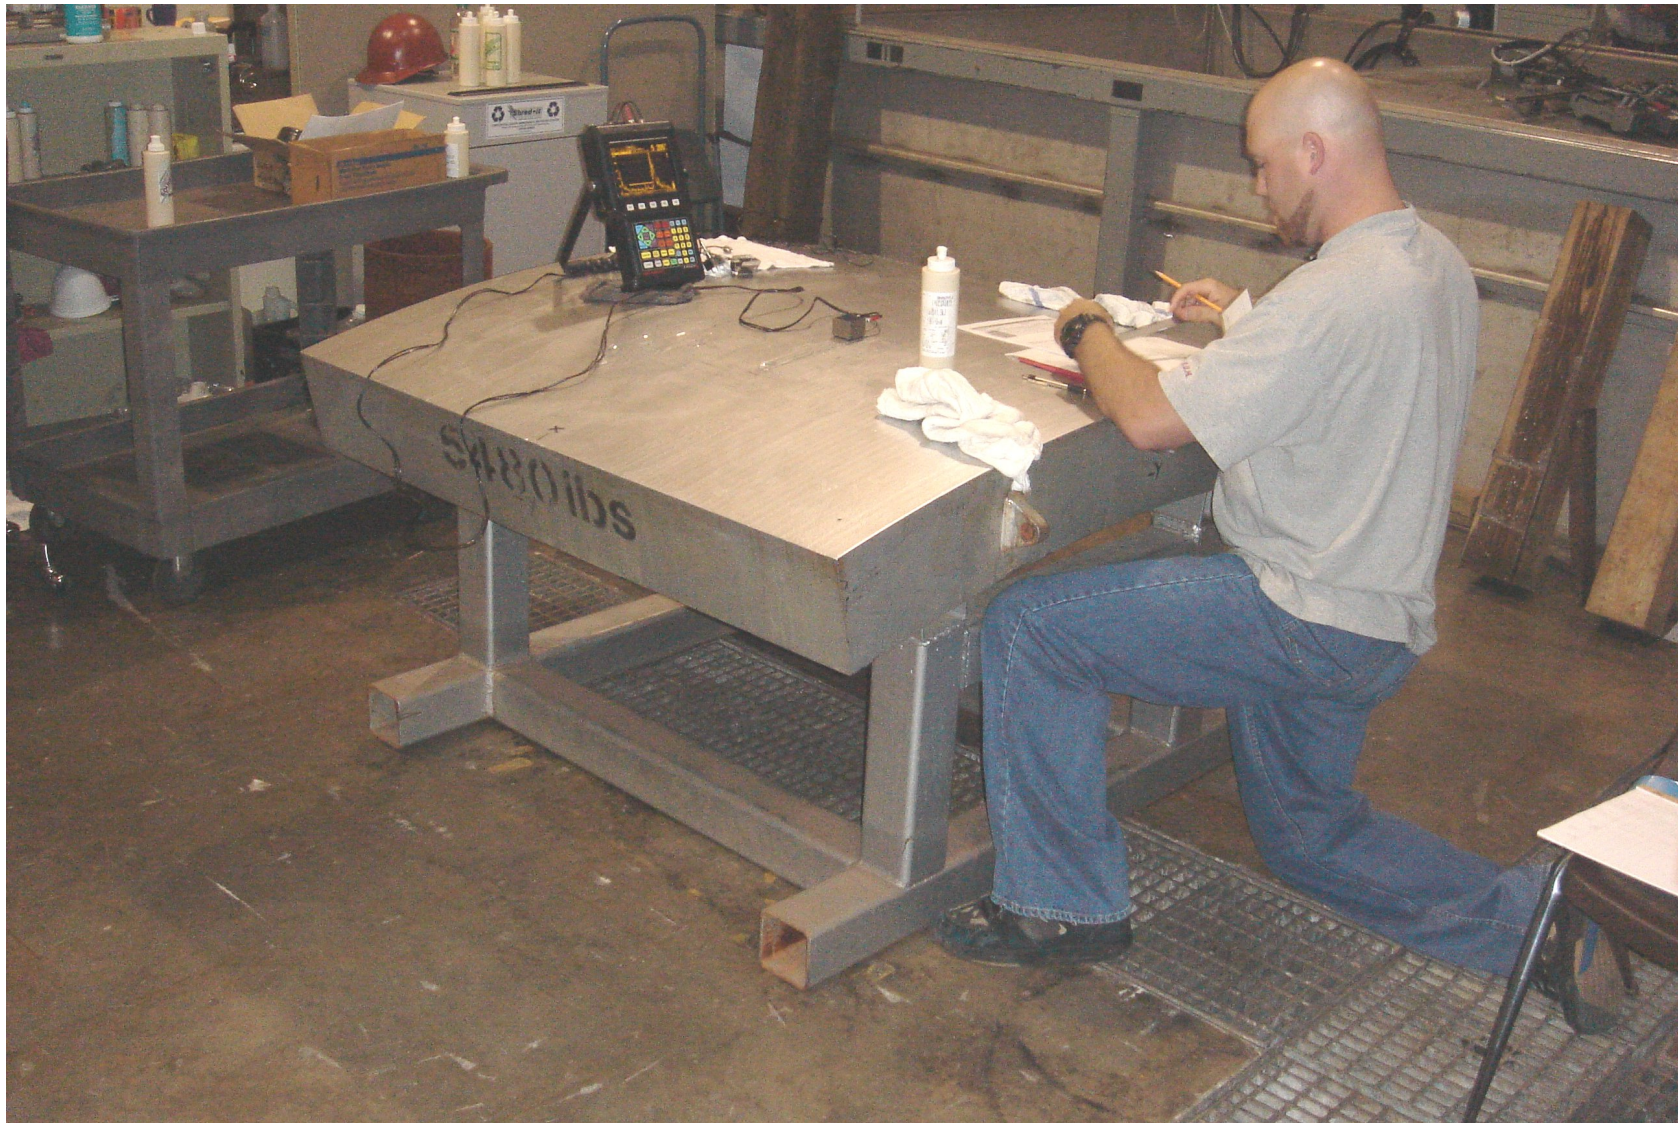
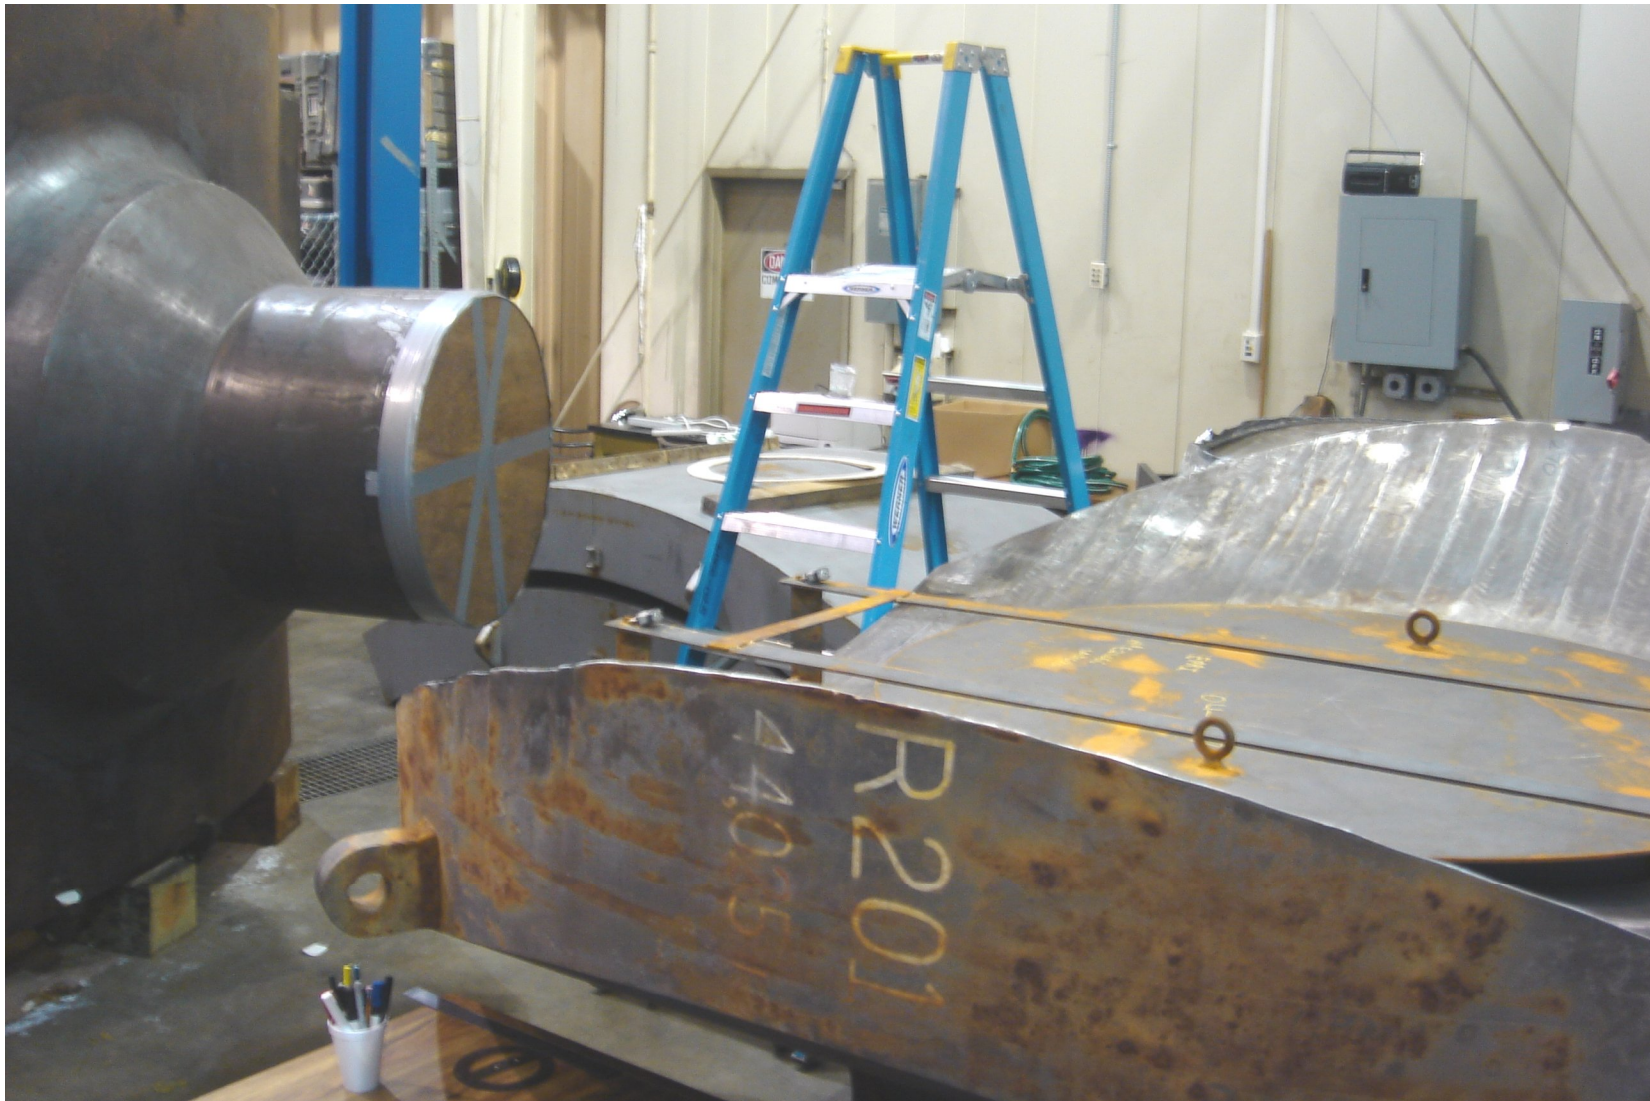
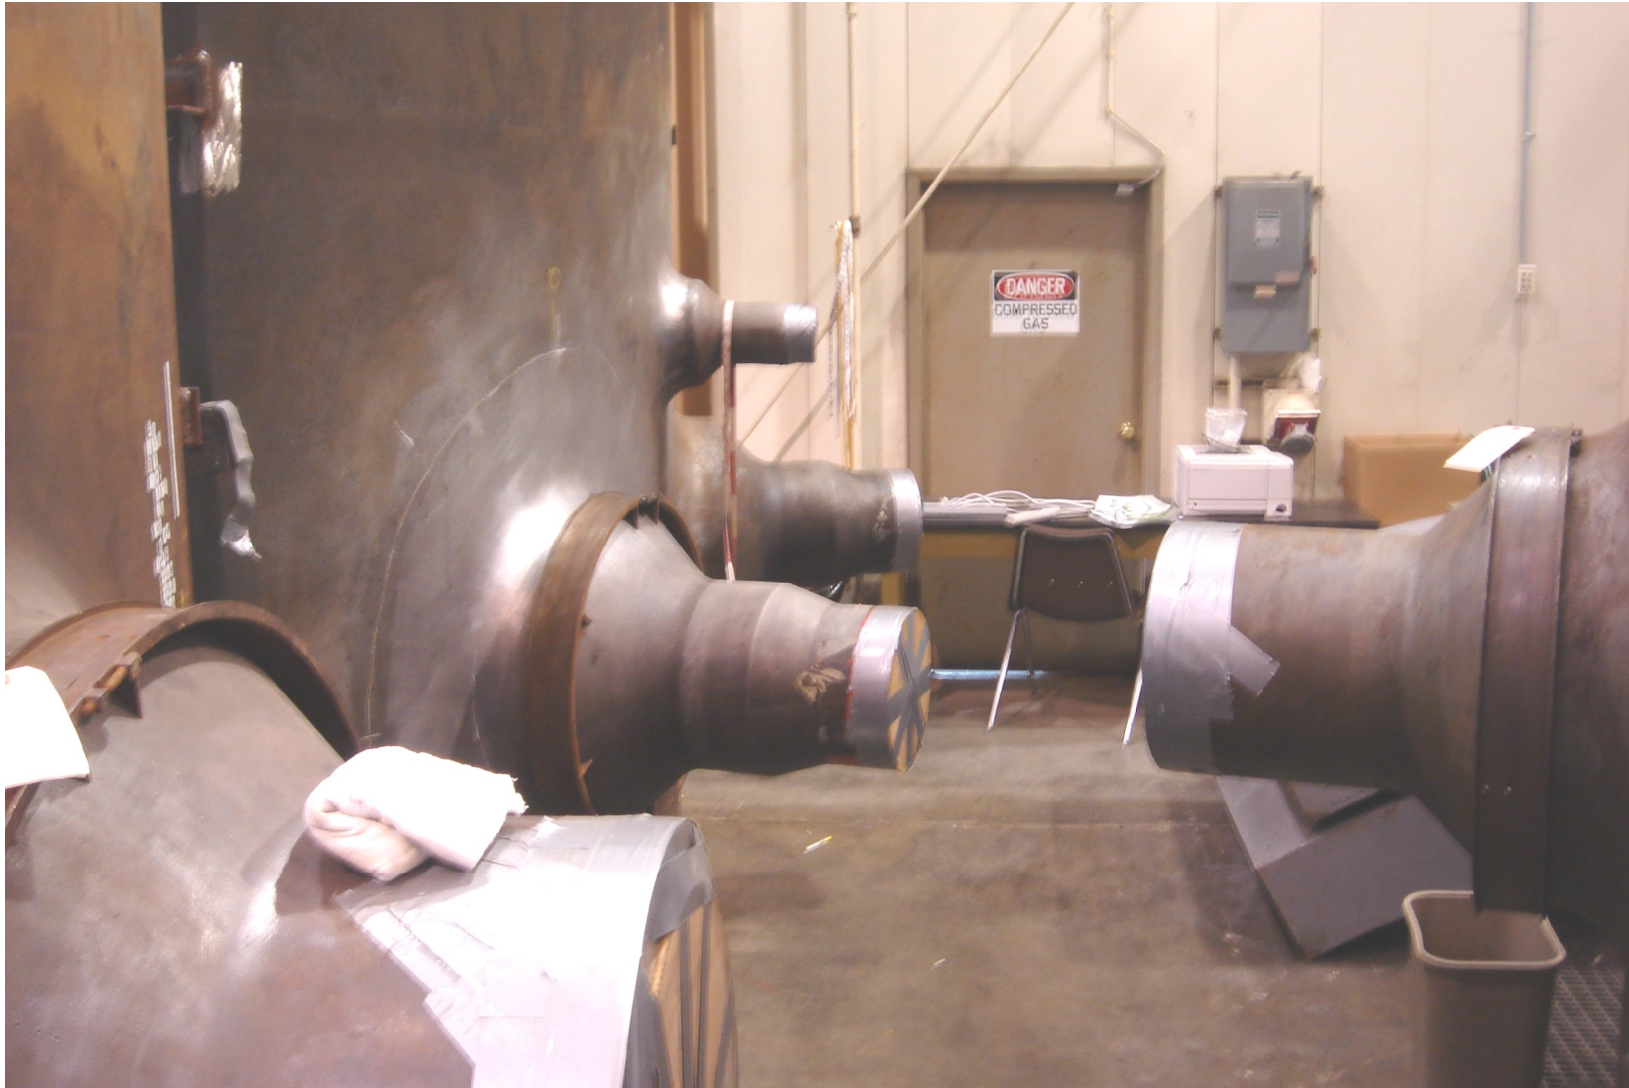
RPV Mockups

- Proof that NDE procedures, personnel, and equipment can detect and properly characterize flaws
 - Use of realistic flaws in realistic mockups
- Total cost of program to date is in tens of millions
 - Mockup cost
 - Administrative cost
- Qualification is impactful
 - RPV procedure qualification may take months, and cost the vendor ~\$0.5M

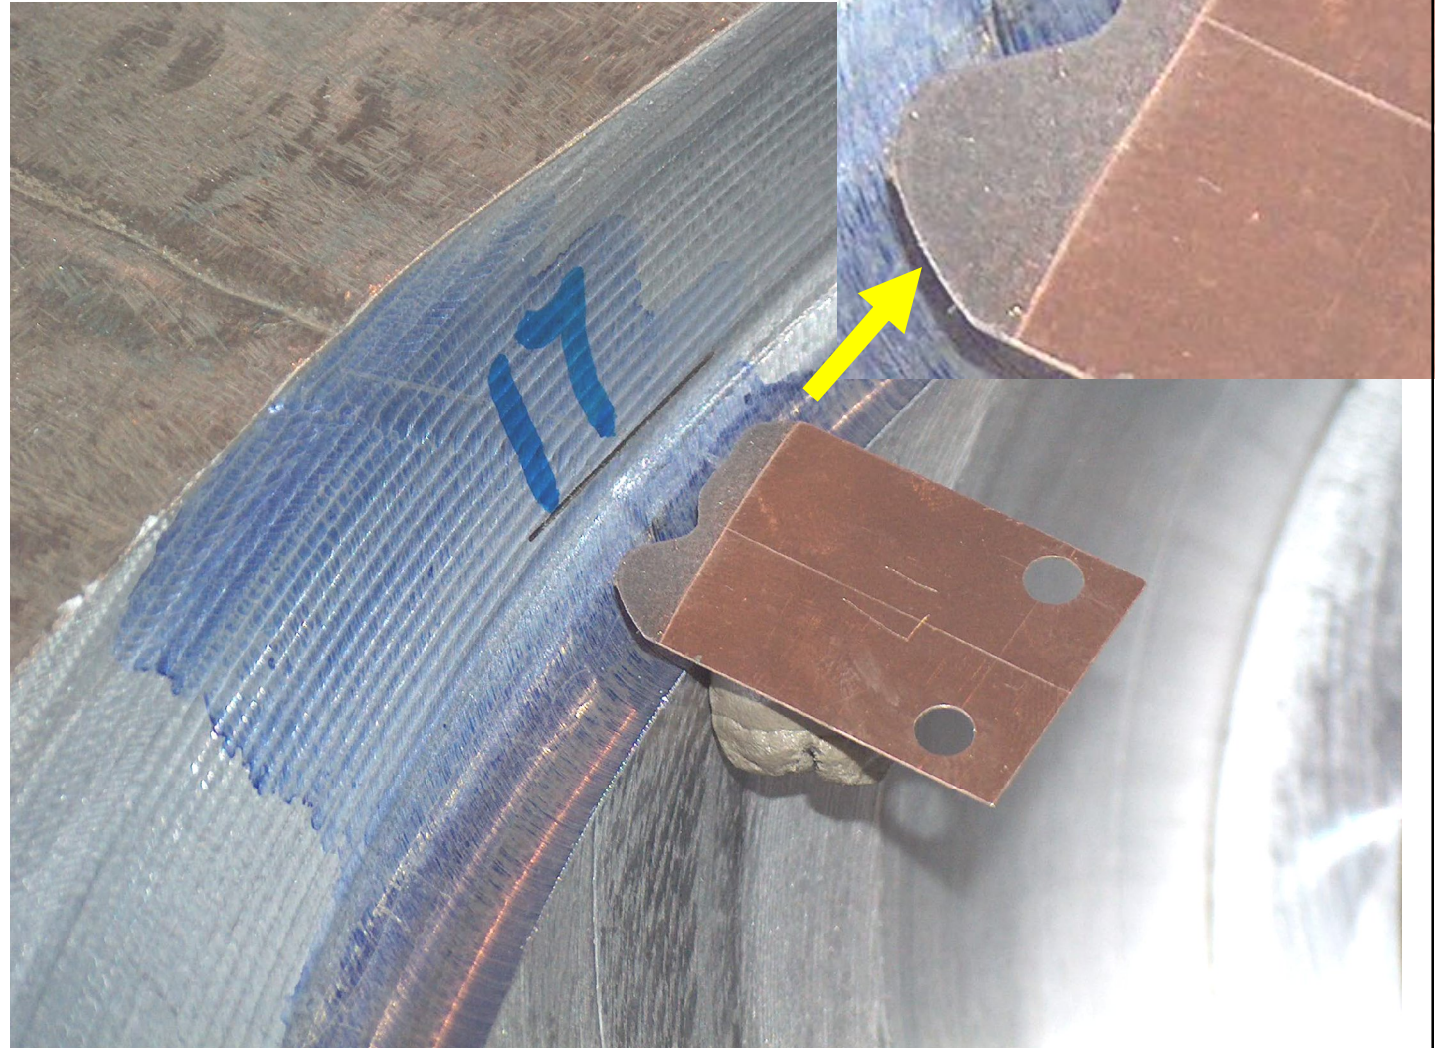
Mockup notches

- Irregular tip shape
